Modern lightning conductors

Killingworth Hedges, Lightning Research Committee, London

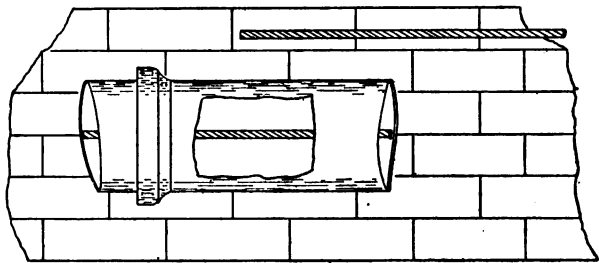
FIG. 30.—SECTION OF OLD CONDUIT, SHOWING EARTHENWARE DRAIN, IN WHICH THE CONDUCTORS WERE FOUND.

The lightning conductors at St. Paul's were discovered by the author in some instances actually insulated from the earth, although they were not very old, as they had been taken into a conduit which was subsequently drained (Fig. 30). To guard against a recurrence of this danger, which is always possible where earth-plates are buried a few feet under the ground, which may be moist at the time but loses all electrical conductivity by drainage operations, the tubular earth has been substituted, as shown in the following illustration (Fig. 31). This is made in two sizes, and consists of a strong perforated steel pipe, either $1\frac{1}{2}$ inches or 2 inches diameter, and furnished

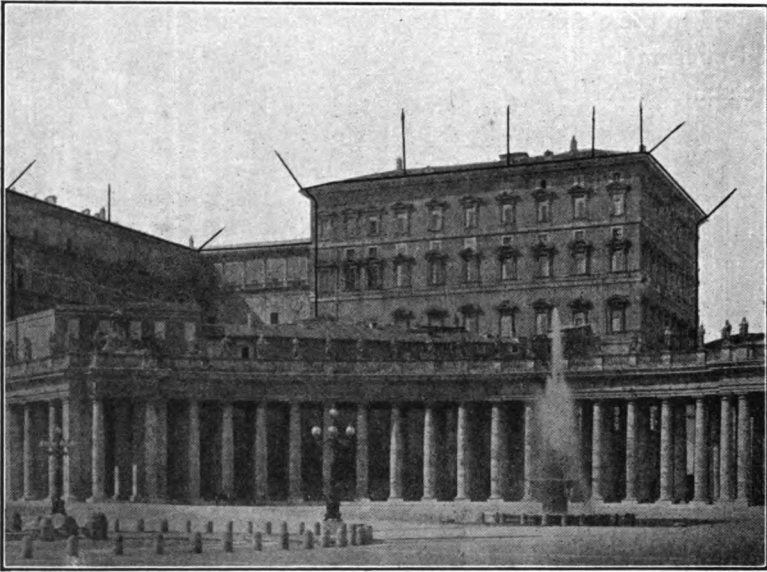
FIG. 40—THE VATICAN.

Vatican buildings, (Fig. 40) are also excellently protected—the high air terminals are built into stone-work projections evidently intended for ventilation, the system of iron conductors is clamped to the base of these vertical rods and is continued over the roofs, being kept away from the tiles by resting on marble supports, and at the end of each ridge an air terminal is arranged to project over the side of the roofs at an angle of about 60 degrees. The use of iron rod enables the protection of this the largest palace in the world to be

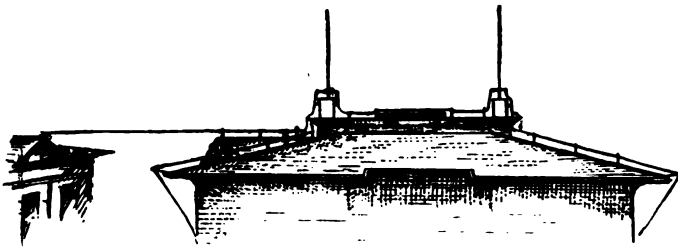
FIG. 41.

Fig. 41 is a sketch of the roof of a hospital at Naples, and illustrates the way the conductors are run over the building; the system is connected to the adjoining wing by a small wire which crosses the intervening space.

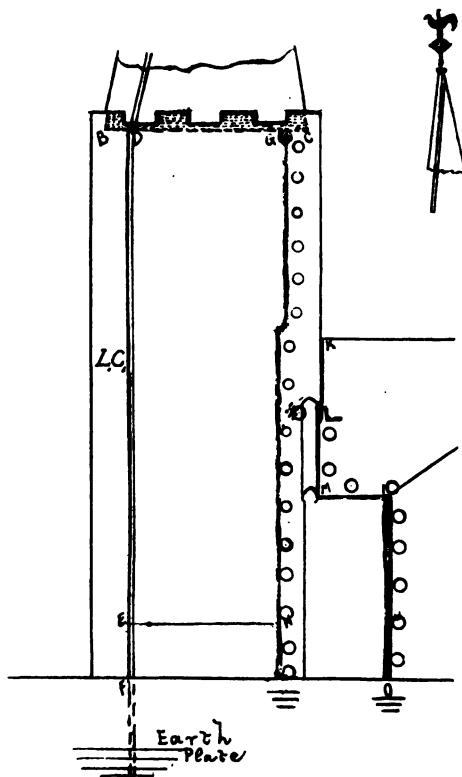
FIG. 43.

NOTE.—The single lightning conductor (which was of modern design and in good order), attached to the vane 120 feet above ground, was not sufficient to carry off the induced charge from the roof. If all the rain-water pipes had been properly earthed and connected to the copper sheeting, the various alternative paths would have averted the damage. The path is indicated by the $\circ \circ \circ$ circles and by the line H E.

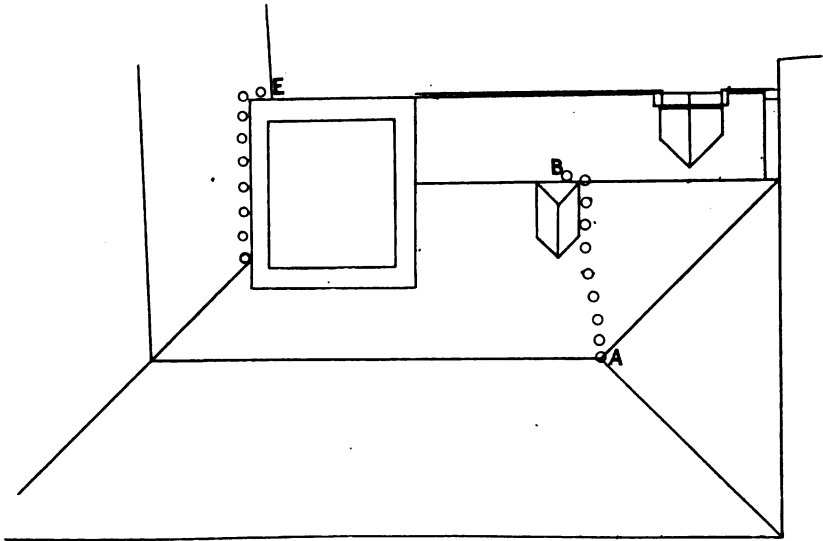
FIG. 47.—PLAN OF ROOF.

No. 64. **Cavendish Laboratory, Cambridge, July, 1902** (Fig. 47).—A conductor of $\frac{3}{8}$ -inch rope was fixed to the tower and went to earth at E; the main stroke followed the conductor, but a side flash struck the hip knob A, about 40 feet away, and made its way to the lead cheek of the dormitory, and at its lowest point B earthed by following a small compo gas pipe (which was laid just below the sill), which it pierced on its way.

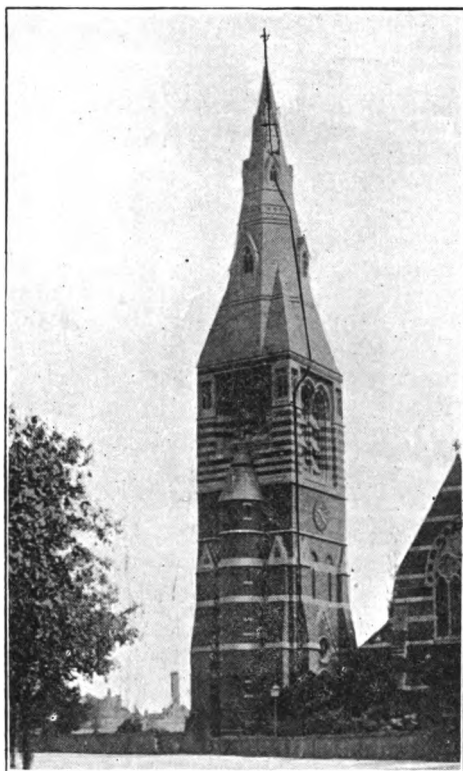
FIG. 48.

No. 65. **All Saints' Church, Maidenhead.**—A lightning rod of $\frac{3}{8}$ -inch round iron projected 6 feet above the top of the spire, and was continued to the iron tie in spire, thence a $\frac{1}{2}$ -inch copper rope ran to the ground (Fig. 48). The cock was knocked off spindle and fell; spire damaged; a hole 18 inches deep made where conductor entered ground; brickwork at foot of tower chipped; no rain.

NOTE.—It was incorrect to use the support of the finial as a conductor, which should have been taken up outside the spire and there connected to the iron rod. This is an example of a conductor, evidently having an imperfect earth, acting sufficiently well to prevent serious damage to the building.

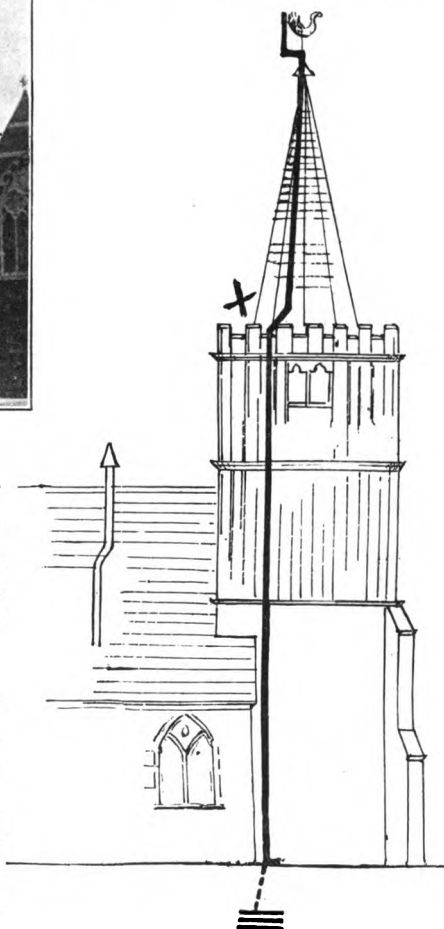
FIG. 49.

No. 66. **St. Andrew's Church, Marks Tey, June 7th, 1902** (Fig. 49).—The

NOTE.—The stroke (*not a very severe one*) was mitigated by the heavy rain. Had a B flash occurred there would have been

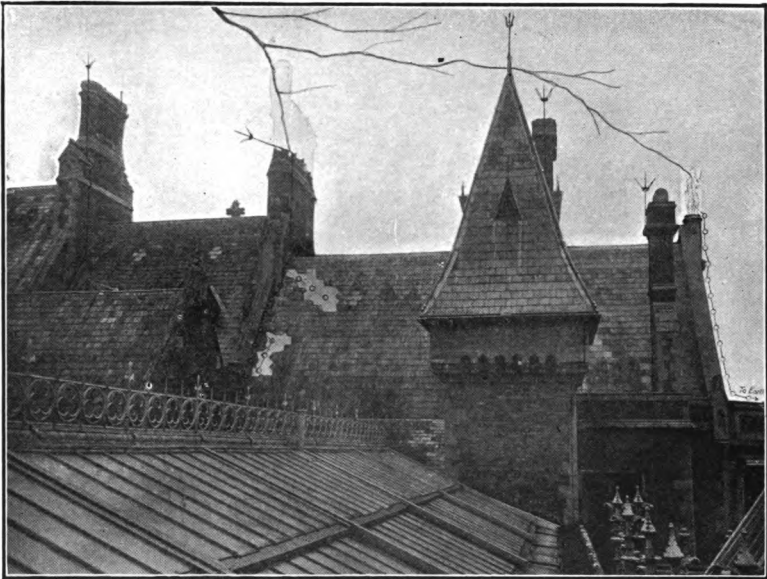
FIG. 50.

NOTE.—The futility of relying on individual rods without some system of inter-connection (see suggestion L.R.C.) is practically demonstrated, also the necessity of connecting up the smallest piece of metal work, as the iron support of the statue was selected in preference to the adjoining rods, whose air terminals were considerably higher. The circles ○ ○ ○ show the paths of the discharge.

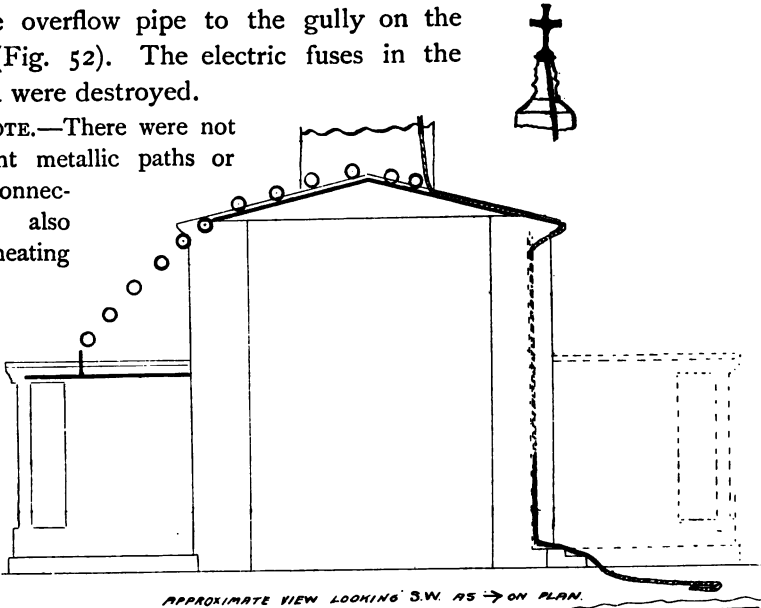
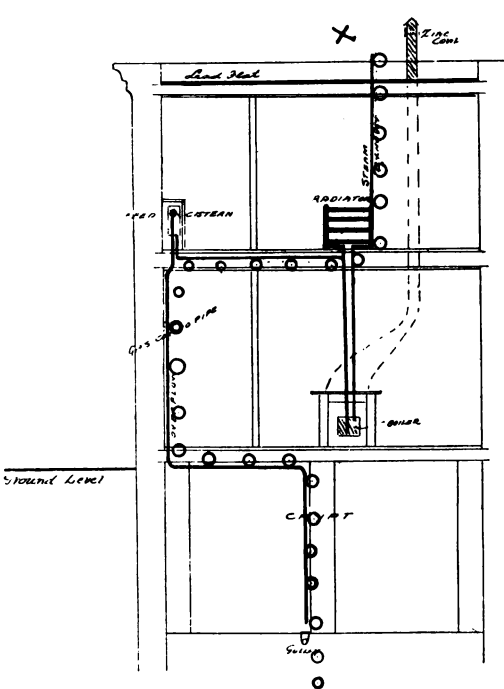
NOTE.—There were not sufficient metallic paths or earth connections; also the heating

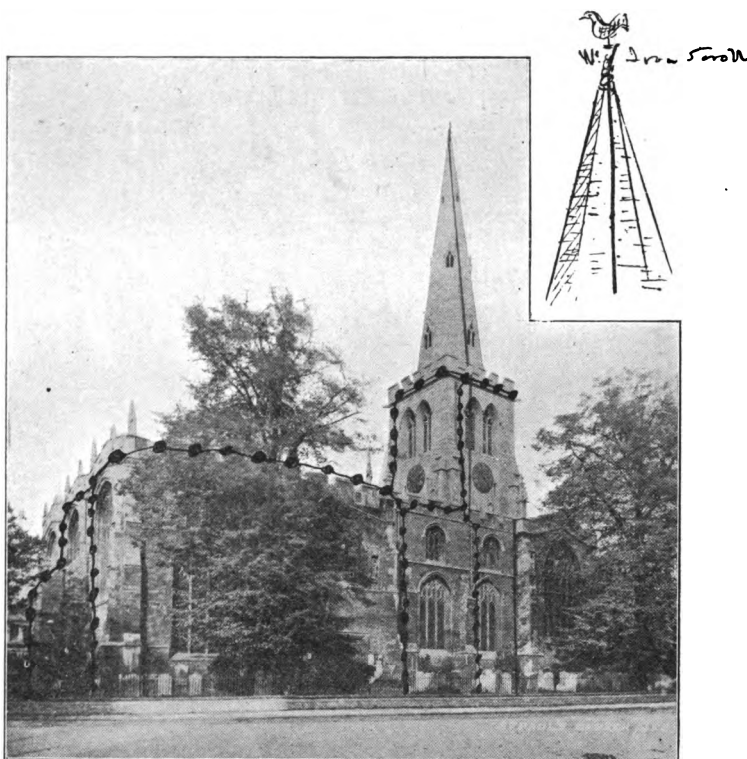
FIG. 55.

light bracket, and along the wire the lightning ran to the switchboard fixed in the church on the outer wall of the choir vestry. Here it fused the main switch, so that no light could be obtained until it was repaired. The fabric of the church itself fortunately escaped damage, beyond the decayed stone work being chipped here and there.

Pieces of roof were thrown 50 yards across the road through the Corn Exchange windows. Where the lightning ran down the lead pipes it did not fuse them.

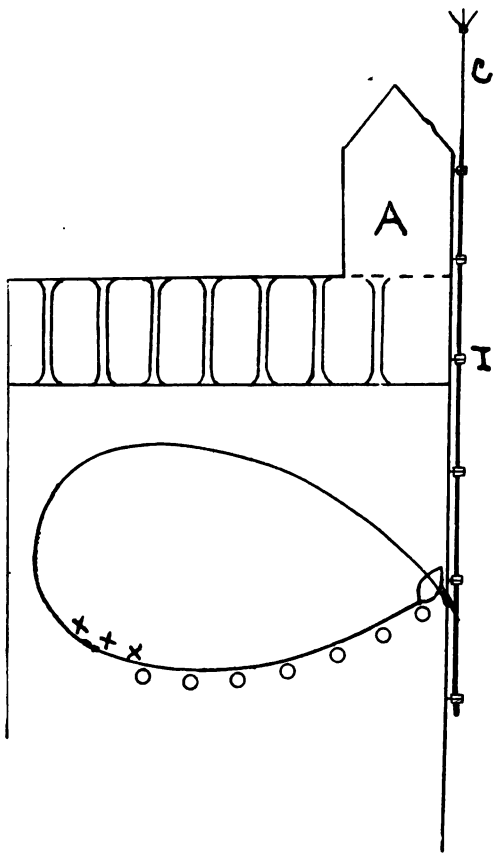
Fig. 56, is 80 feet. The conductor of copper wire rope (seven $\frac{1}{8}$ inch strands), ran from one baluster, A, to ground in a vertical line, fixed with metal holdfasts carrying glass insulators, I. The air terminal, with four points, C, projected well above the one baluster, and in addition there was a length of the same wire rope placed round the coping at the top of the tower, immediately below the eight balusters. This portion of the conductor had no insulators, and a loop was made at one end as shown in plan on Fig. 56, and the other was attached to the conductor. The lightning first struck three of the balusters, avoiding the air terminal, demolishing them, and passed by the horizontal cable, fusing it at the loop, to the main rod and to earth. There was no disturbance at the ground, the earth connection being good, but about 30 feet down from the air terminal a piece of stone, midway between two glass insulators, was splintered. The points of the air terminal do not appear to have been struck. Considerable damage to the roof was occasioned by the falling stones, and the necessary repairs cost £600 to £700. The position of the three balusters which were destroyed is shown by x x x and the path of the flash by o o o

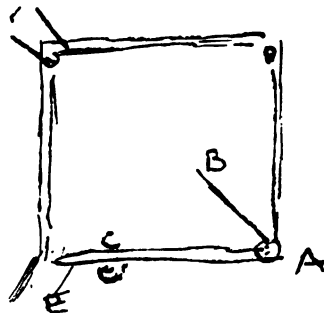
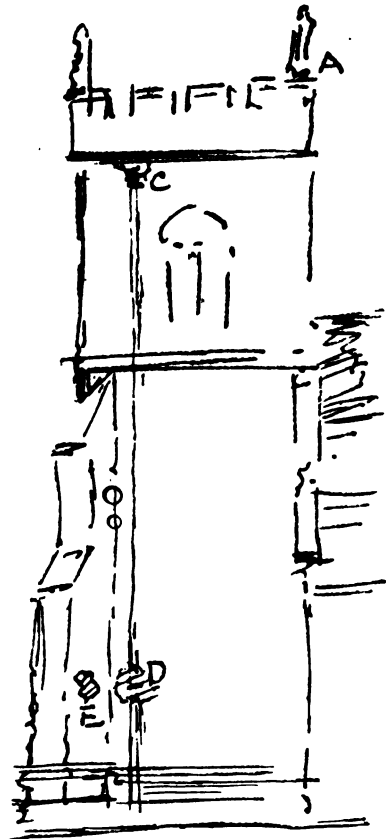
FIG 57

St. Botolph's Church, Cambridge, unprotected. Observer: W. Fawcett, M.A.—The lightning struck the south-east pinnacle **A**, ran down a rusty iron rod on to the lead roof **B**, from there it went to the lead fall pipe **C**. At **D** the lead had been changed to iron, and here it blew a hole about 1 foot 6 inches by 6 inches deep out of the wall with such force that a piece of stone broke the wall at the side of the buttress at **E**. (Fig. 57.)

NOTE.—This clearly shows how the rain-water pipe acted as a conductor, and had it been continuous the damage would have been confined to the destruction of the pinnacle.

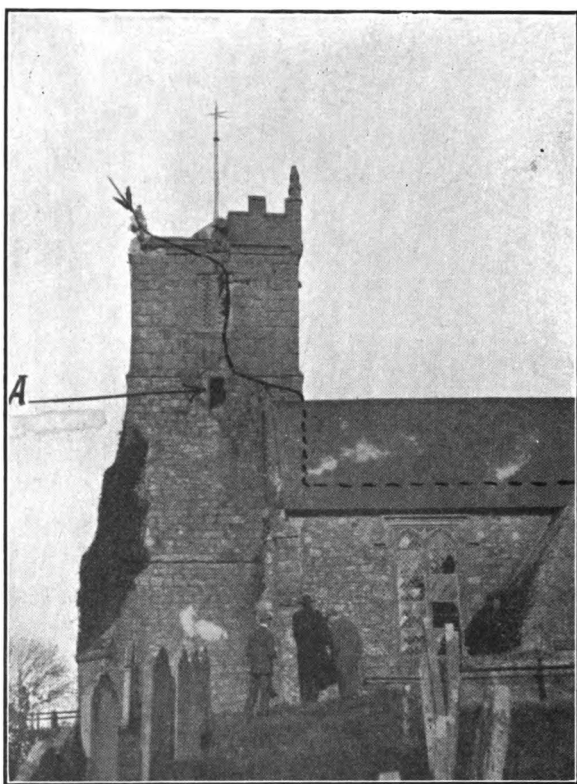
FIG. 58.

Fig. 58. The lightning, missing the flagstaff, struck the pinnacle and parapet, passing between the latter and the lead flat forming the tower roof, which was uninjured, acted as an explosive inside the tower, destroying the stairs, clock casing (marked A), and deal paneling, falling on the tower arch next to the nave, broke

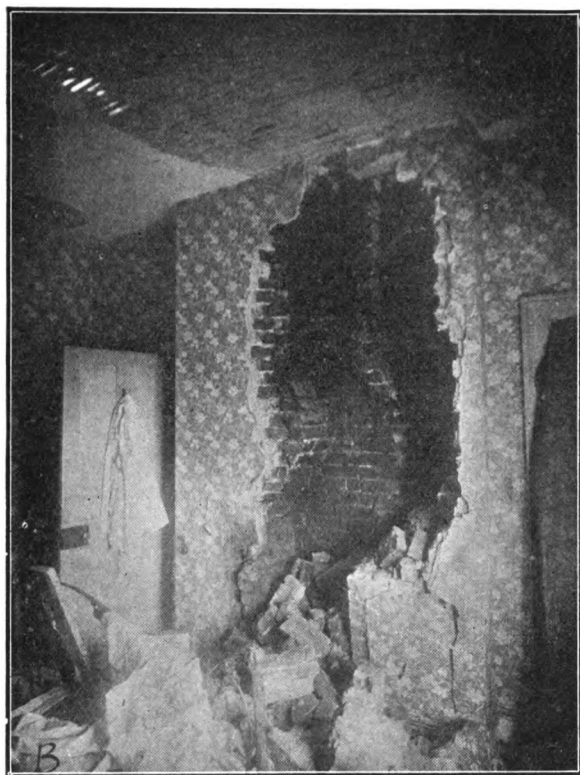
FIG. 62.

Southborough Vicarage, Tunbridge Wells, May, 1903. Observer: C. H. Strange.—Detached building standing on a hill about 400 feet above sea level. The mechanical effect of the discharge was very great, the chimney struck being indicated by dotted lines, Fig. 61. It then blew out the face of the chimney breast in the bedroom below, as shown in Fig. 62, where **B** shows position of the bedstead, and finally wrecked the fireplace in the dining-room immediately under. During the same storm a number of the

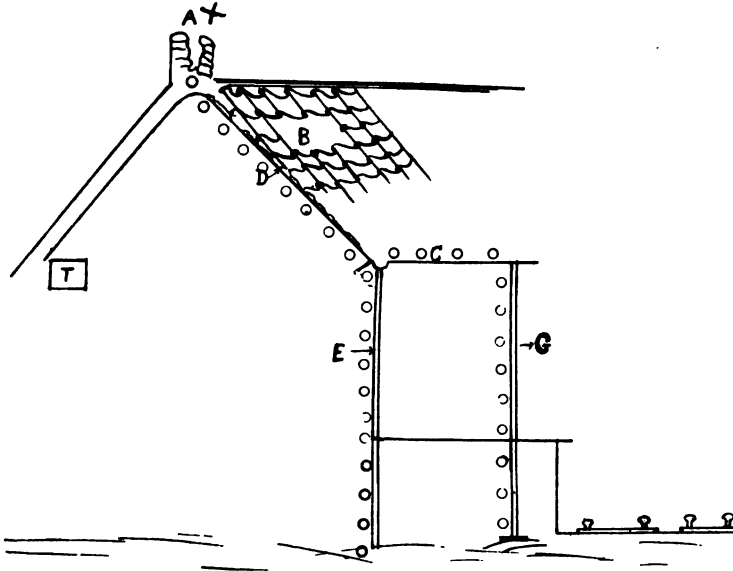
FIG. 63.

Gloucester Station, Oct. 1901. Observer: C. Hooker, Surgeon.—Chimney split at **X**, large hole, **B**, in roof of porters' room, glass roofing of platform below **D** much broken; lightning went to earth by rain-water pipe, **E**, and iron column, **G**. **T** is a water

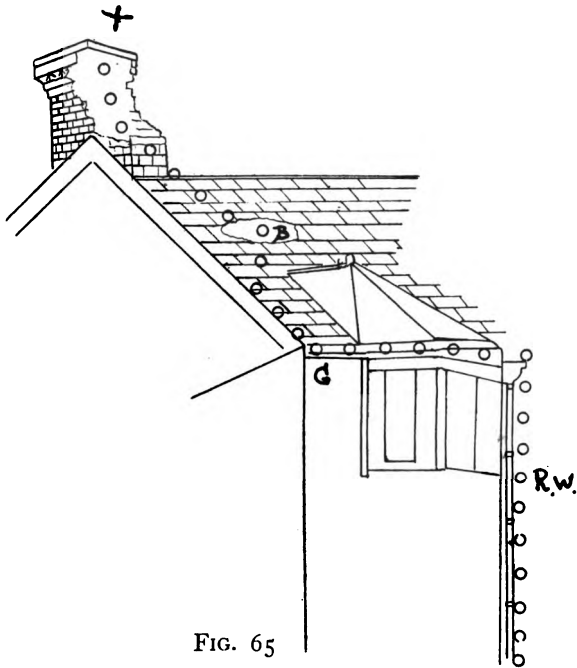
FIG. 65

NOTE.—This case is quoted because it shows the general course of a flash, and how easily the damage could have been prevented by running a few small conductors from the top of the chimney to the guttering and rain-water pipes; the latter prevented further damage by acting as a lightning rod, but as the joints were not bonded as recommended at page 29, their joints at the sockets were broken.

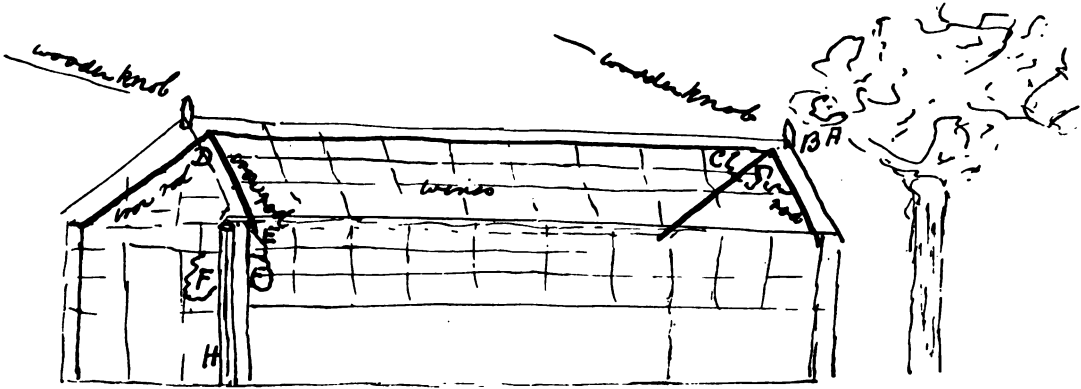
FIG. 66.

NOTE.—This is a very interesting case, showing that the higher tree was ignored and the small wires perfectly conducted the flash without fusing same, and if they had been in contact with the pipe **H** probably even the glass would not have been broken.

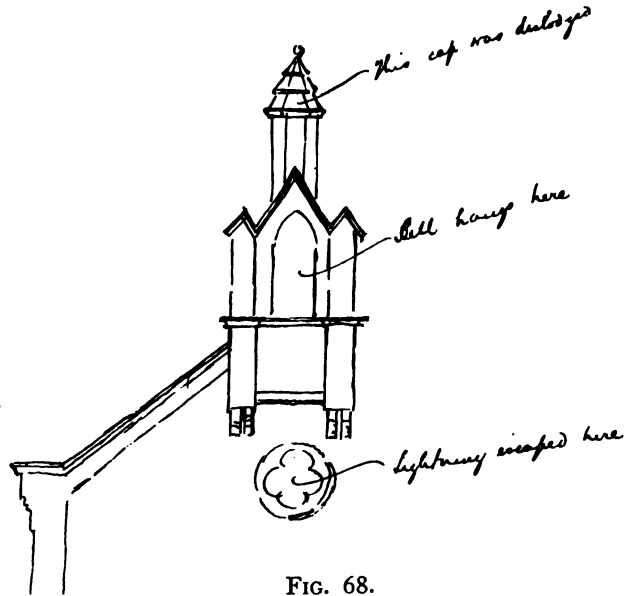
FIG. 68.

No. 42. **St. Stephen's Church, Carnoustie**, August 1901. Observer: J. P. Bruce, Architect, who gives sketch, Fig. 68.—The stone cap of belfry was dislodged, the lightning passed inside along chain pull of bell, which it broke, then escaped through the rose window, part of the king post in roof being broken away; another part of stroke earthed inside by means of a gas pipe.

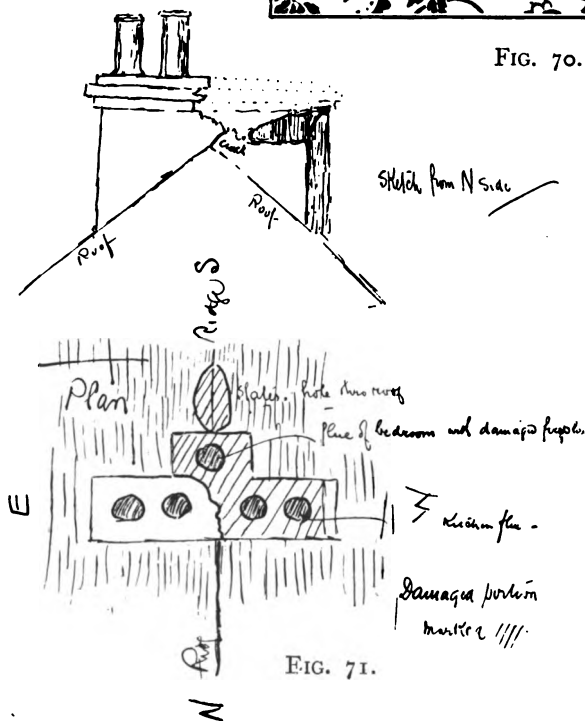
FIG. 71.

No. 90. **Greenfield, St. Melons, Monmouth, May, 1903.** Observer: H. Heywood.— Dwelling house. "The effect as if an explosion," the chimney stacks being blown right and left, one piece of stucco being

picked up 120 feet from chimney. Ridge tiles destroyed, flash passing down the flue; the grate displaced 5 feet, iron chimney-piece overturned. (See Fig. 71, which shows part elevation and plan of chimney).

NOTE.—The plan shows how necessary it is to protect the ridge of roof with horizontal conductors as recommended (see L.R.C. Suggestion 2). The interior damage is similar to that shown by Fig. 62.

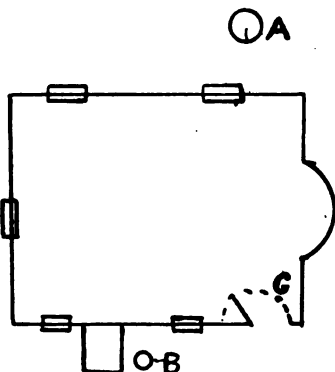
FIG. 72.

NOTE.—This shows that no reliance can be placed on the shielding effect of a conductor fixed to a higher point, and the station ought to have had a separate rod.

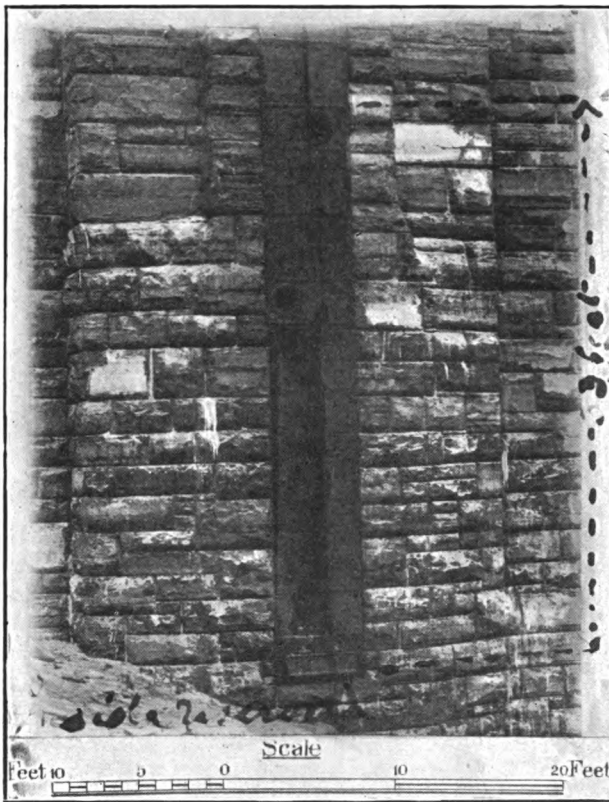
FIG. 74.

Myrthyr Tydfil Waterworks. Cracking of cast iron plates. Observer: George F. Deacon, M.I.C.E.—In the
